ENERGY-SAVING TEST REPORT

INSULADD - Insulating Paint Additive

Center for Energy-saving Research

Huanan University of Science and Technology

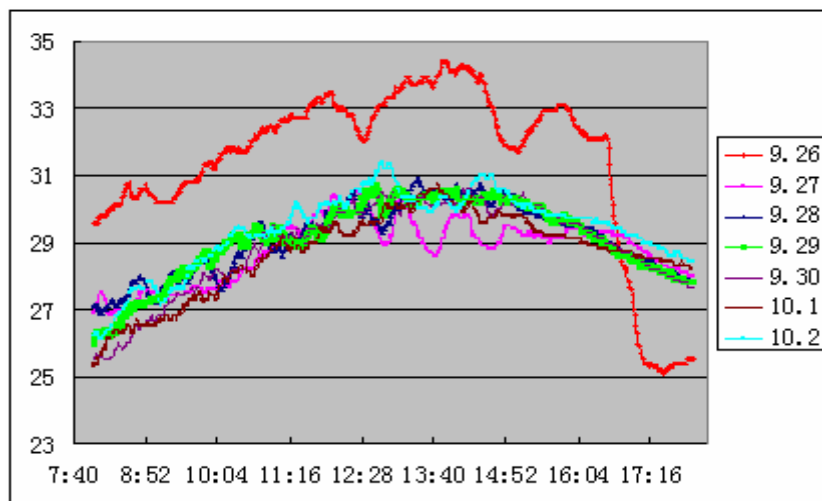
Figure 1 Outdoor Air Temperature during Testing Period

(Data provided by Wushan Weather Station, Guangzhou, Guangdong, CHINA)

Test condition Throughout testing the air-conditioning units at both the UR and TR rooms were maintained at 26°C, the government required winter temperature setting. Temperature probe readings were recorded via the digital data collection device on ten-minute intervals. Rooms adjacent to the UR and TR rooms also had their room temperature controlled by A/C at 26°C. Electricity usage by the UR and TR rooms were recorded on hourly basis to determine the usage throughout the day. Total number of days tested were seven; most days were sunny, occasionally cloudy. Maximum air temperatures outside during the days were all above 30°C.

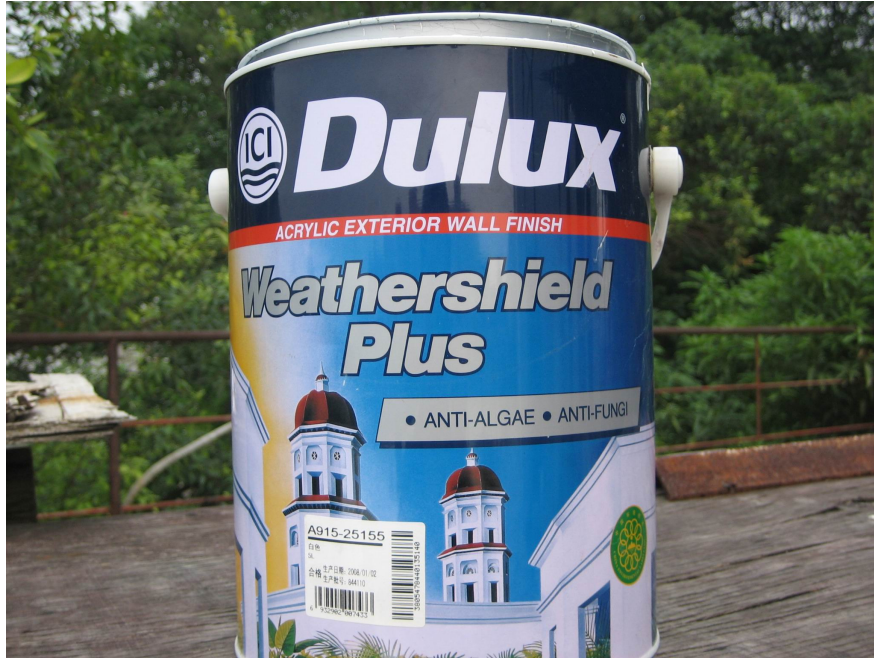
Ordinary exterior paint used in testing

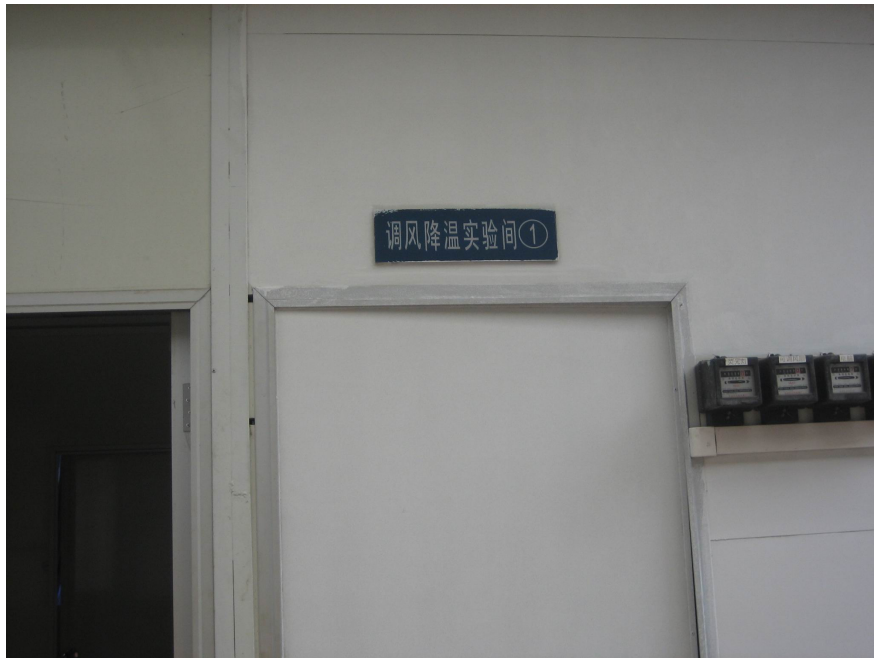
Front of the Treated Room

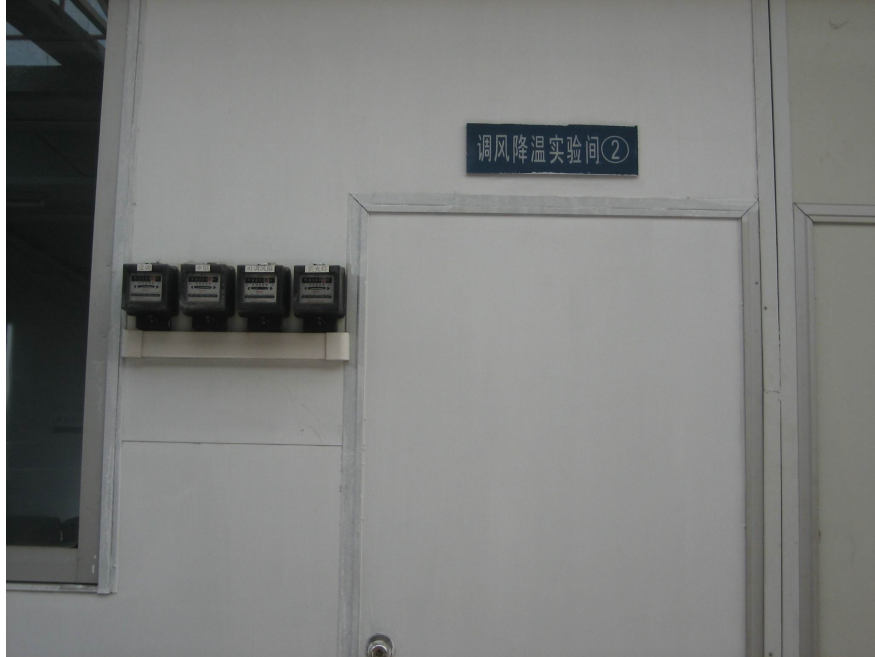
Front of the Untreated Room

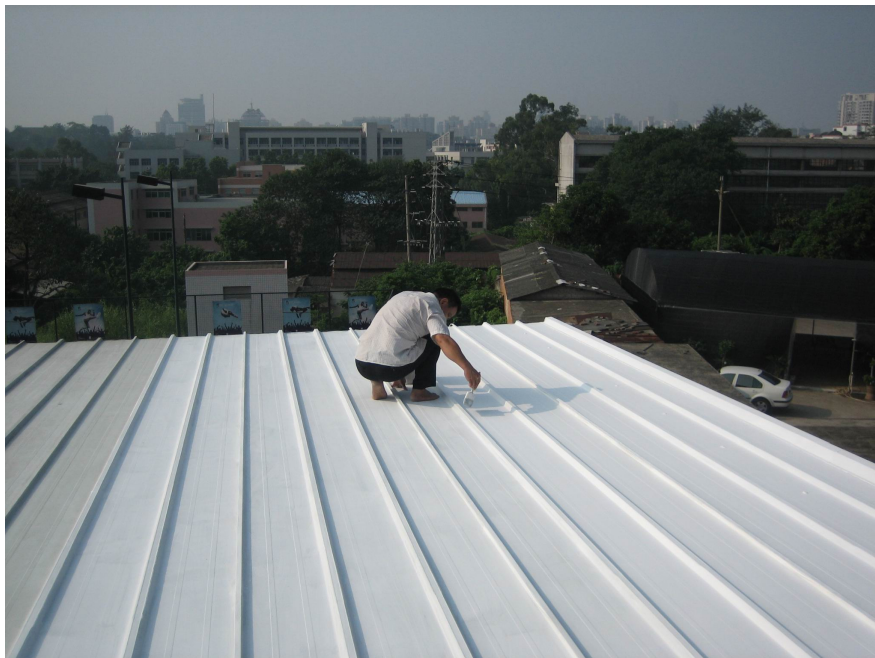
Painting the rooftop

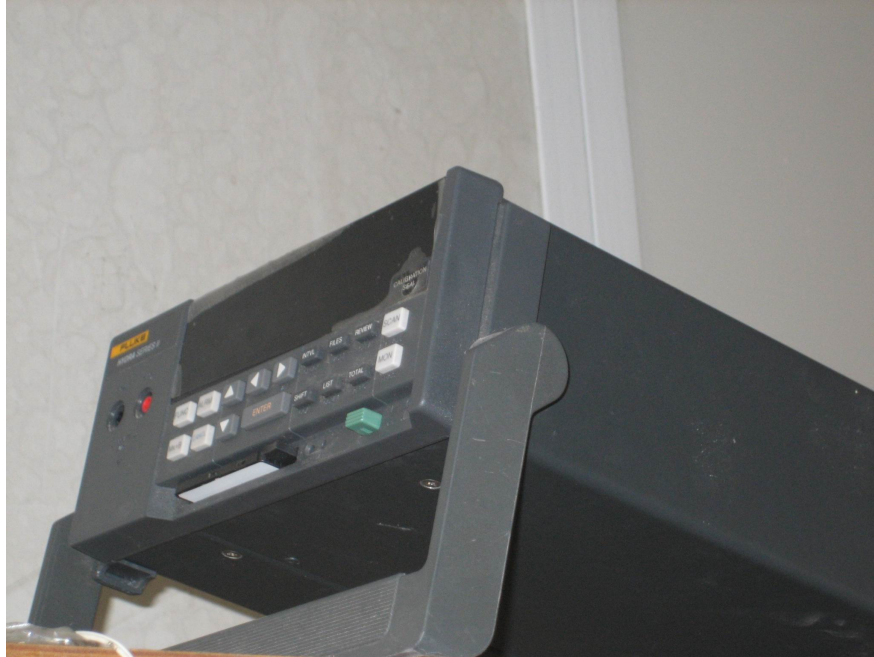
Digital data collection device - Fluke

All instruments and equipment are FLUKE Hydra digital data collection type. All 14 temperature probes are thermal couples.

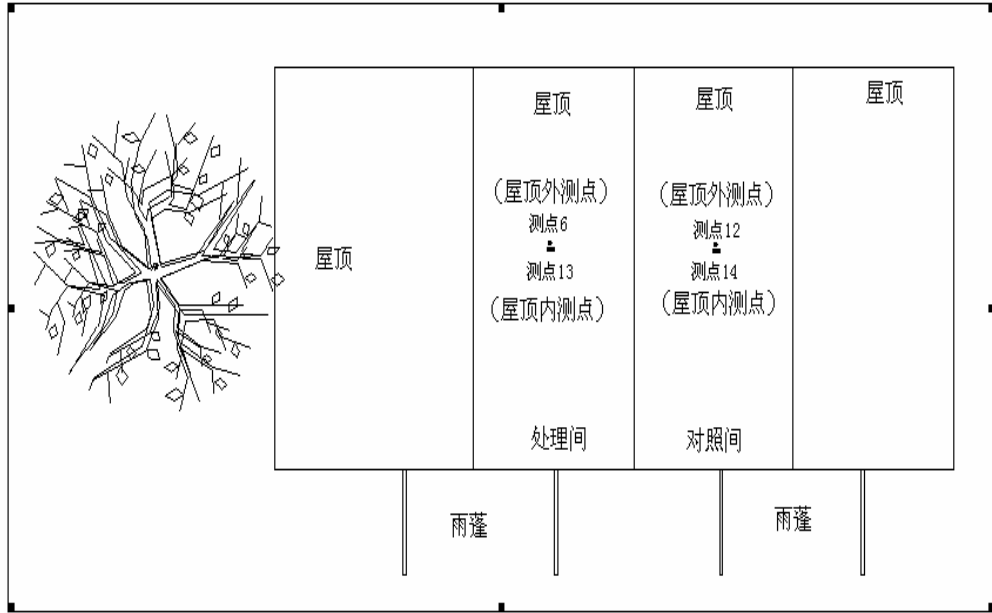
Layout of Thermal Probes (Rooftops)

Thermal probes for temperature measurement at various points in the rooms are given in Table 1 below. Exact locations of these probes are shown in Appendix 2.

temperature measuring points	
1	1	TR's southern exterior wall
2	1	TR's southern interior wall
3	1	TR's indoor air temperature
4	1	TR's northern interior wall
5	1	TR's northern exterior wall
6	1	TR's roof temperature
7	1	UR's southern exterior wall
8	1	UR's southern interior wall
9	1	UR's indoor air temperature
10	1	UR's northern interior wall
11	1	UR's northern exterior wall
12	1	UR's roof temperature
13	1	TR's ceiling temperature
14	1	UR's ceiling temperature
Total	14

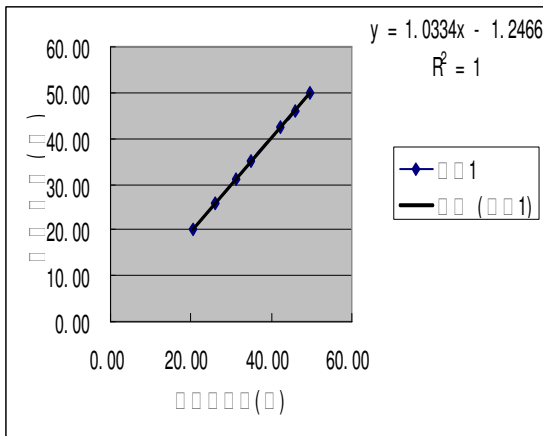
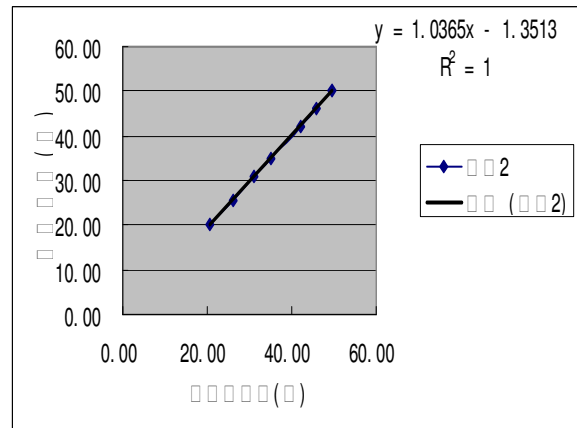
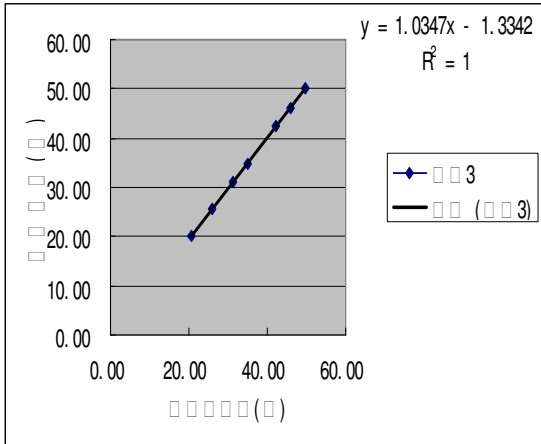
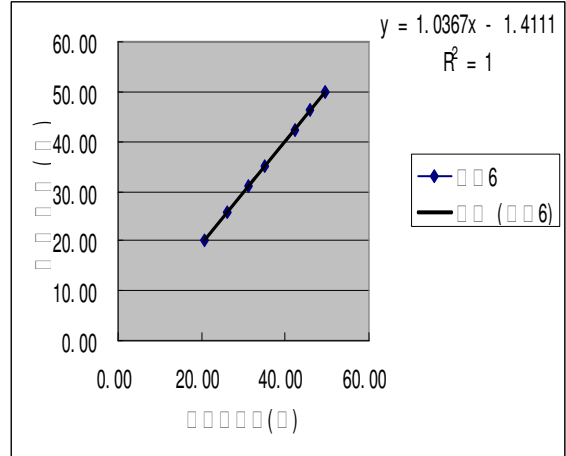
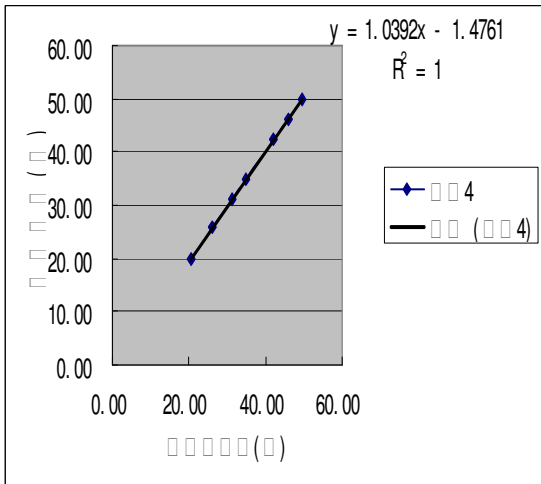
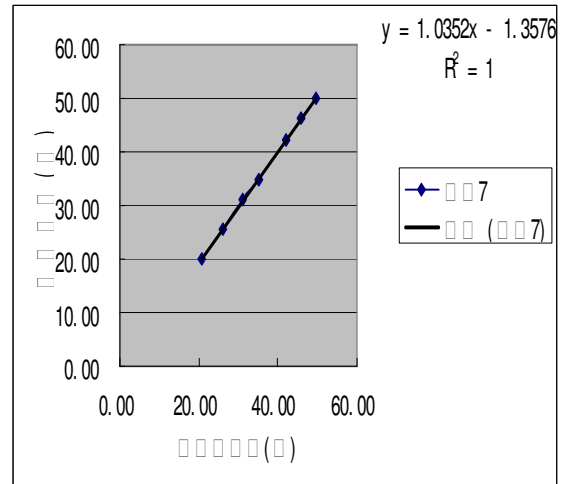
Appendix 3 Calibration of Temperature Measurement Probes

Upon completing the field measurement, all collected temperature data were calibrated against an officially calibrated mercury thermometer; and then all went through a linear regression analysis (see Appendix 3). The obtained data were then corrected against these curves.
